Hypothesis of Explosion in the Left Wing Outer Fuel Tank of Tu-154M due to Electrical Ignition of Fuel-Air Mixture

Professor **Jacek F. Gieras**, PhD, DSc, Fellow IEEE

University of Technology and Life Sciences, Bydgoszcz, Poland

Smolensk Conference, Warsaw, 22.10.2012

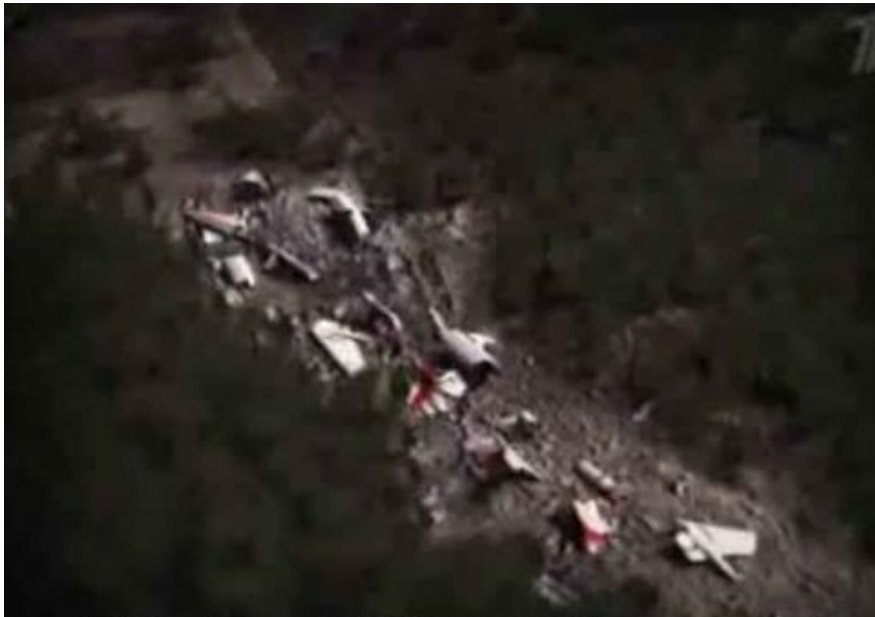
Lost of the left portion of wing

According to the Report of Polish Committee for Investigation of National Aviation Accidents KBWL, Annexure 4, Section 4.10.3, ***the lost of the left portion of the wing has caused the burst of the left fuel tank Nr 3, which is placed between rib nr 14 and 45.*** The severance of the 6.1-m long tip of the left wing was between the ribs nr 27 and 28.

Since the severance of the wing tip as a result of collision with 0.3 to 0.4-m diameter birch tree is rather impossible, the problem should be stated in opposite way: ***The burst of the left fuel tank Nr 3 caused the lost of the left portion of the wing***

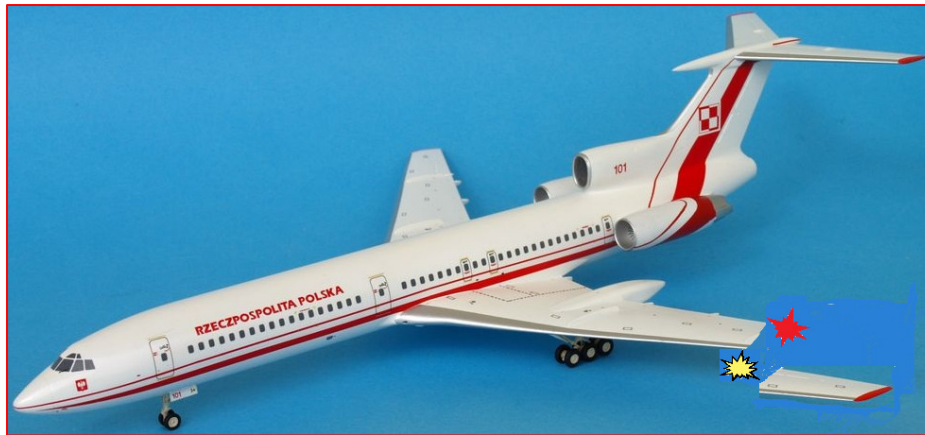
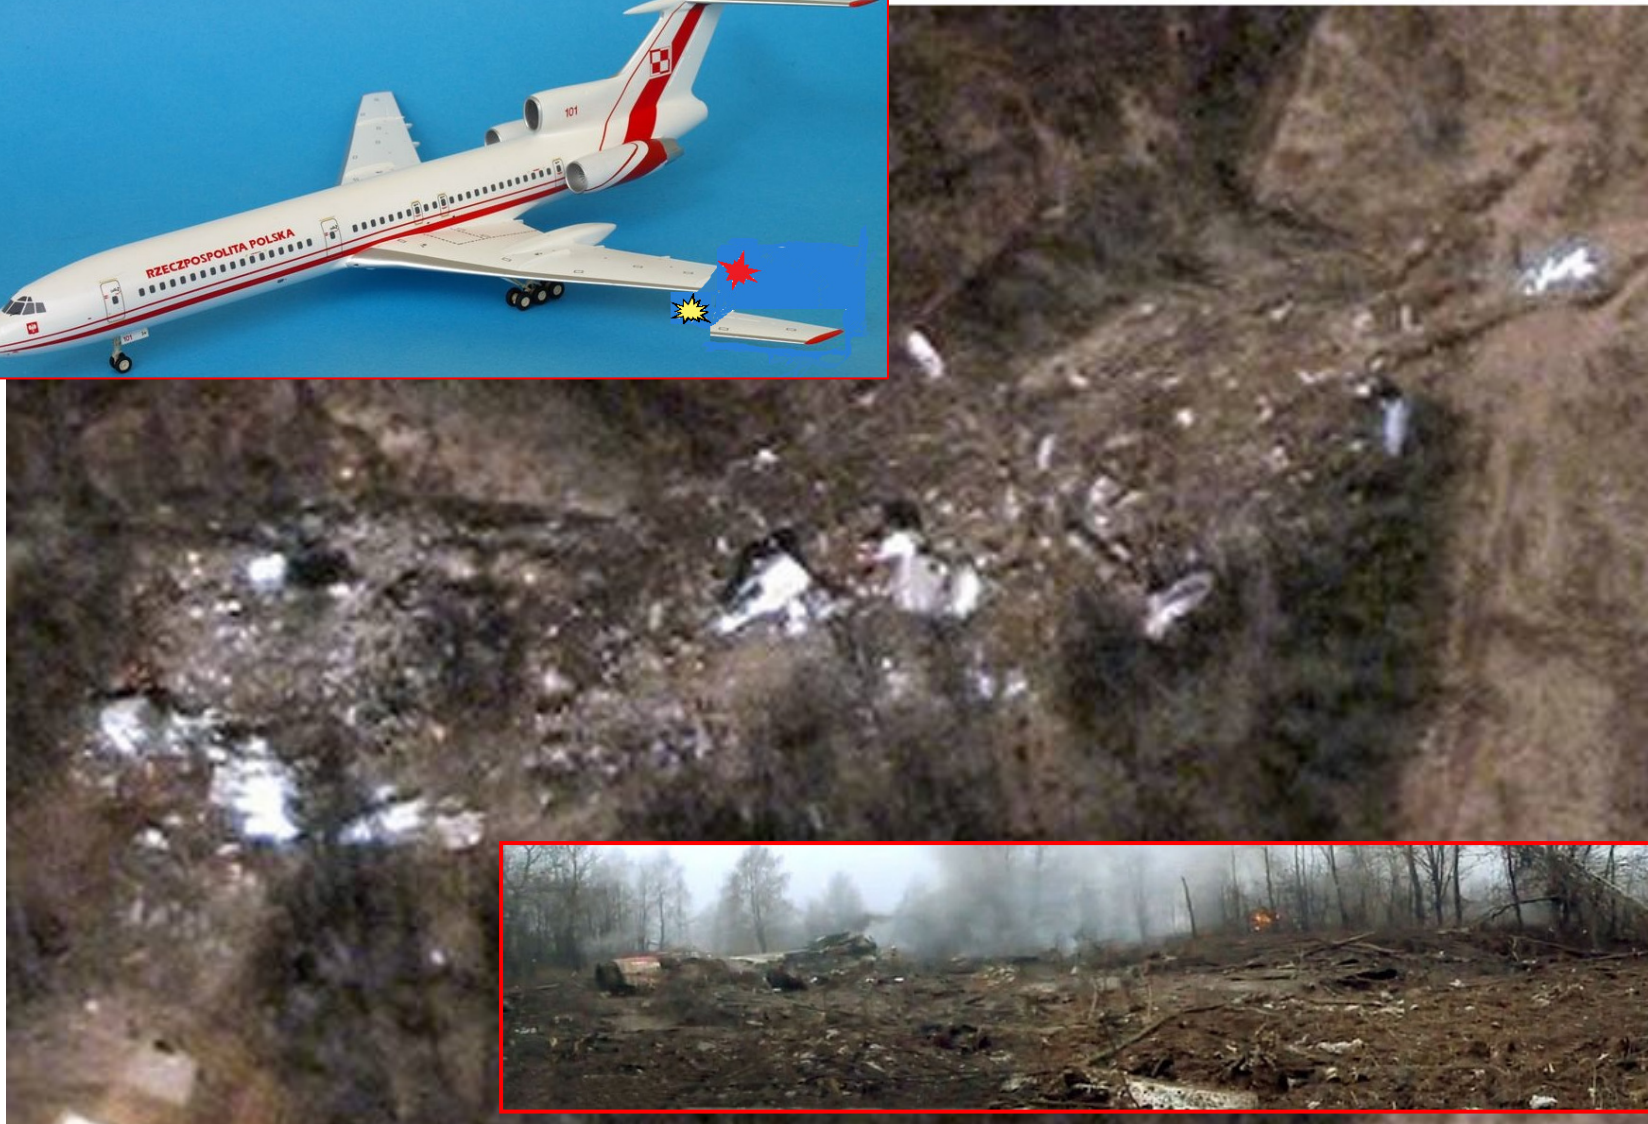
Only a **hypothesis of explosions** in the air can justify such fragmentation

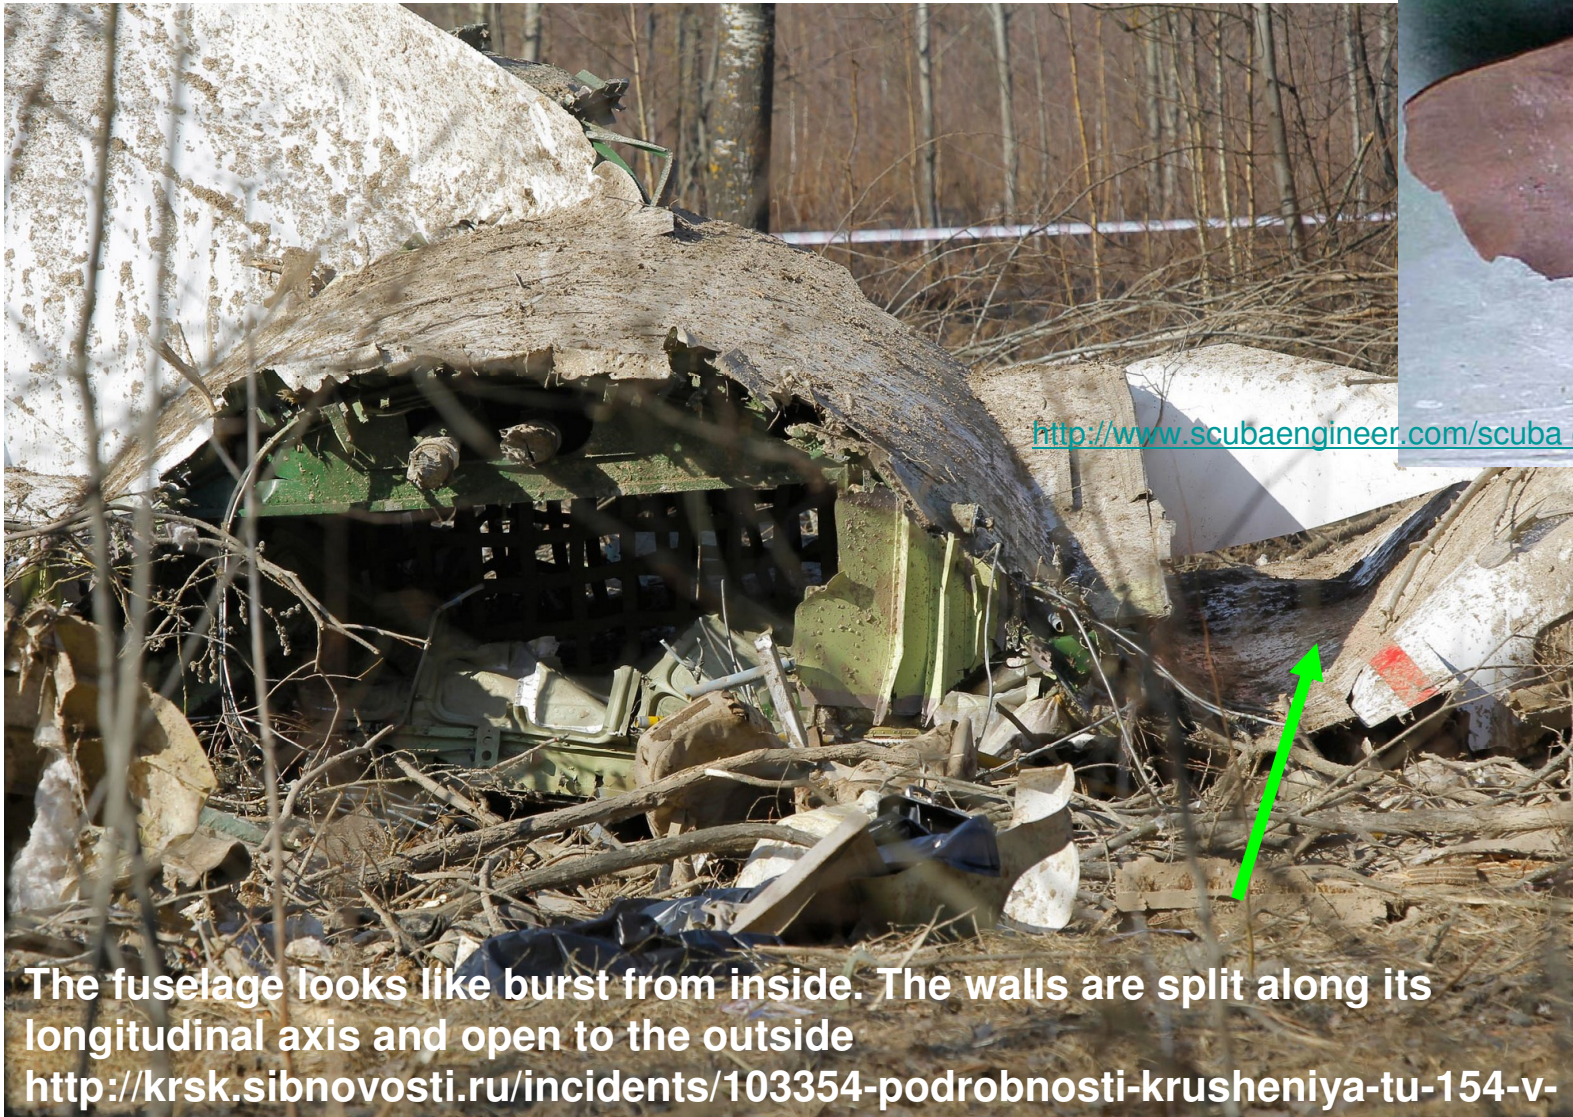
Comparison of the fuselage at the crash site on April 10, 2012 with burst gas cylinder

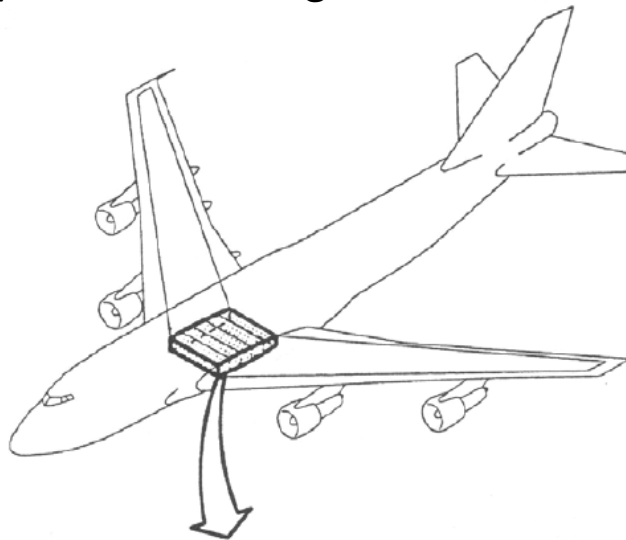
(a) CWT of Boeing 747

Short circuit in a bundle of electric wires caused fuel-air mixture ignition

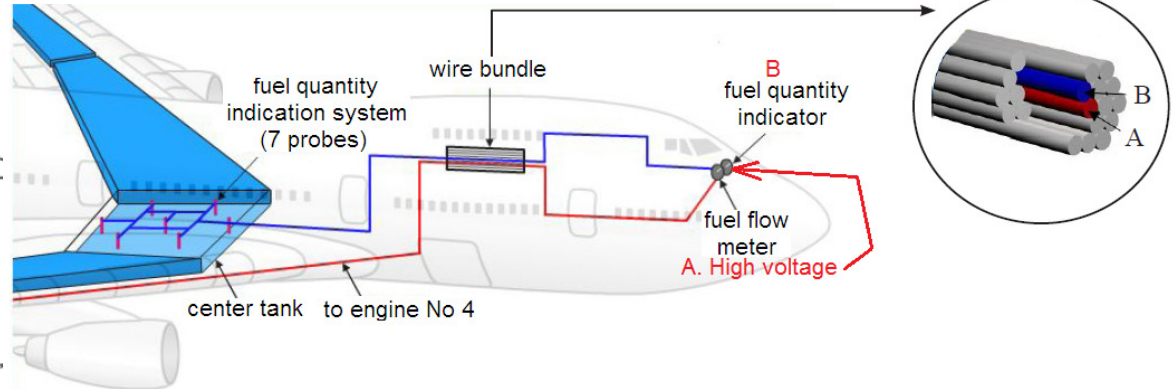
(b) High voltage from the fuel flow meter A passed to the fuel quantity indication system (FQIS) because of a short circuit in the wire bundle.

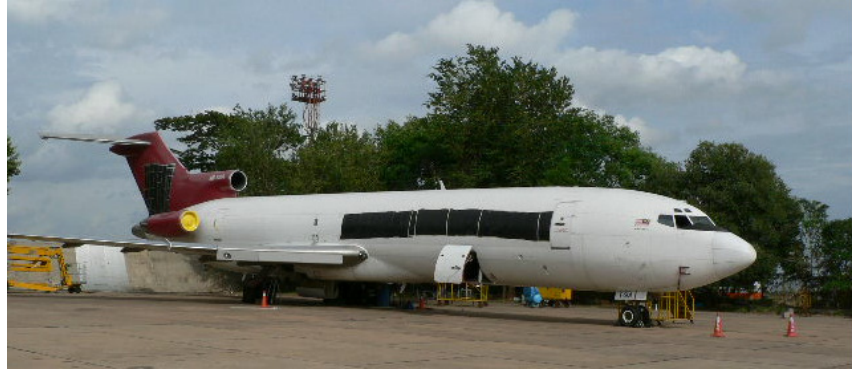
(a) Explosion destroyed the structural integrity of the left wing.

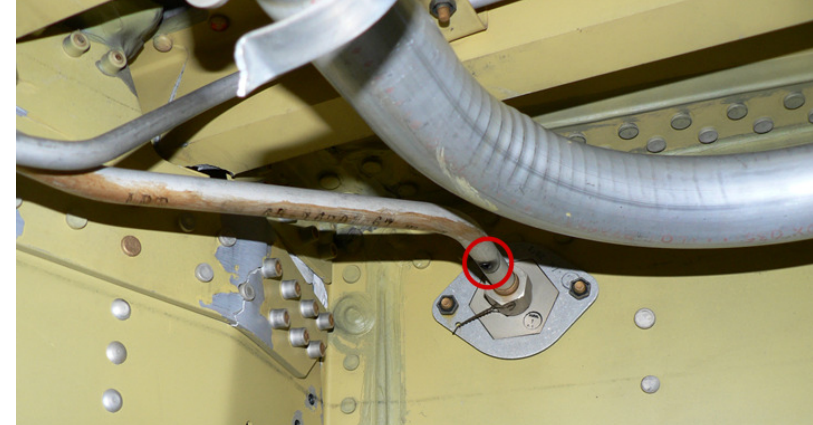
(c) Damaged electrical installation and electrical arcing in aluminum tube with 115-V AC cable feeding fuel pump motor in the left wing tank

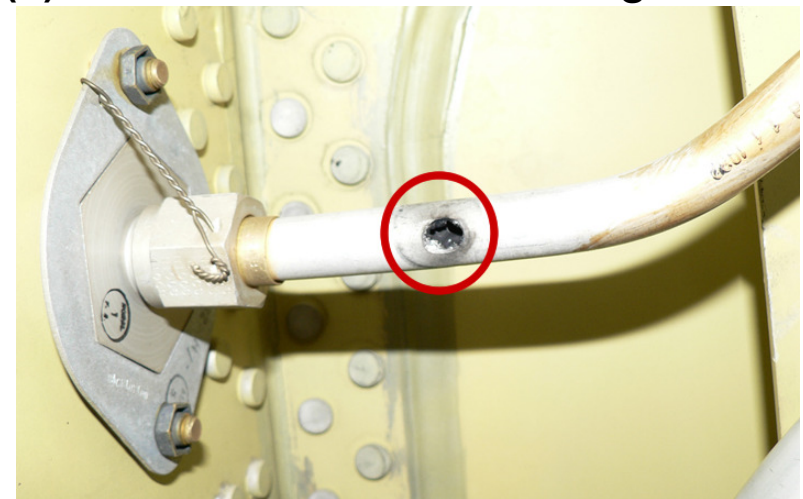
(d) Evidence of electrical arcing
