# SELECTED TECHNICAL ASPECTS OF TU-154M SMOLENSK AIR CRASH ON APRIL 10, 2010

JACEK F. GIERAS

**ABSTRACT.** This is a collection of reports that consists of three parts. The author is a Professor of Power Electrical Engineering, so he focuses on the Tu-154M power electric system and all aspects of the air crash that relate to electrical equipment and wiring.

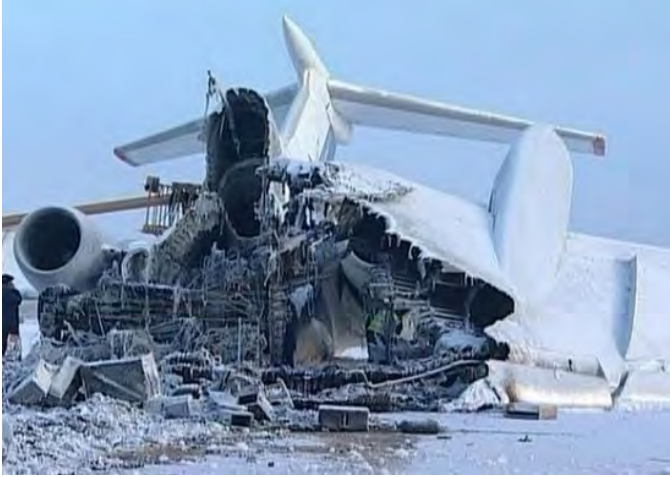
Figure 1.12: Tail part of Tu-154B2 RA-85588 after fire at Surgut airport on January 1, 2011 [30].

There is known at least one case of main generator failure, i.e., the Tu-154B2 RA-85588 while operating flight 7K 348 on January 1, 2011 from Surgut (located on the Ob River near its junction with Irtysh River) to Moscow (Domodedovo). The plane was taxiing to the runway while preparing for its takeoff from Surgut when the right engine caught fire on the taxiway (Fig. 1.12). Three out of 126 passengers and 8 crew members died.

Russia’s Interstate Aviation Committee (MAK) released their final report (in Russian) concluding the probable cause of the accident was the outbreak of fire in the right generator panel located between frames 62 and 64 in the cabin [30]. The generators were connected on the network after the engine start and exit to the idle mode. The cause of the fire was an electrical arc-

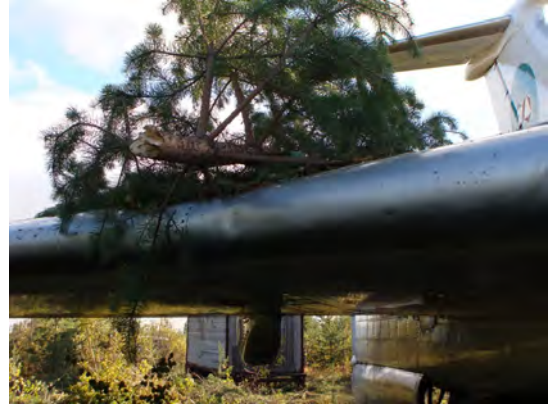
Figure 1.14: Emergency landing of the Tu-154M RA-85684 at abandoned air strip near town of Izhma on September 7, 2010. The impact was damped by the young trees which have grown since the airport was closed. The photograph shows the right wing that cut a pine tree [46].

On September 7, 2010, the Tu-154M RA-85684 Alrosa Mirny Air Enterprise Flight 514 aircraft from Udachny (located 1370 km northwest of Yakutsk on the Markha River) to Moscow suffered a complete electrical failure *en route*, leading to a loss of navigational systems. The electrically operated fuel transfer pumps were also affected and prevented transfer of fuel from the wing tanks to the engine supply tank in the fuselage.

After emergency descent below cloud level the crew were able to spot an abandoned air strip near town of Izhma (Fig. 1.14). The abandoned air strip is 1325m, whereas the Tu-154 requires a minimum of 2200 m. The aircraft landed at a speed of 350 to 380 km/h, faster than normal, due to the lack of flaps. Although the flaps are powered by hydraulics, the switches operating them are

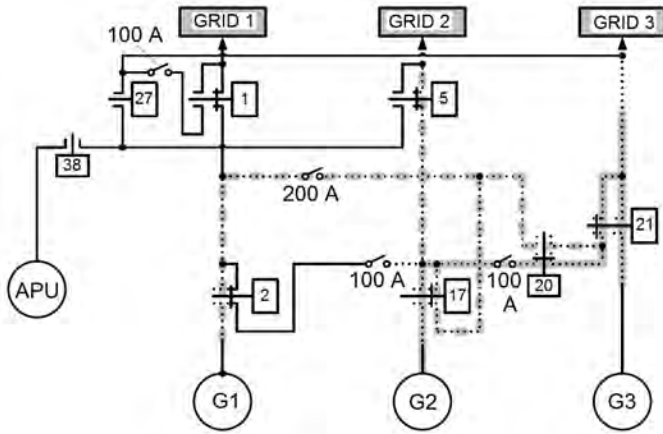
Figure 1.13: Closed electric circuit on assumption of abnormal scenario corresponding to the 21st contactor TKS233DOD “switching generator No 3 on grid” [30].

ing produced by electrical currents exceeding 10 to 12 times the nominal current when two generators not synchronized with each other were brought online but got connected together instead of being connected to parallel busses (Fig. 1.13). Under such conditions the currents can reach more than 10 times the nominal current of the generator. The unsynchronized operation of the generators can be attributed to:

1. Poor technical conditions of contacts TKS233DOD (Fig. 1.13) responsible for connecting the generators with the electrical busses, that were damaged by prolonged operation without maintenance. A contact normally open was welded and fractured insulation material moved between contacts that are normally closed. These abnormal contact positions led to the connection between No 2 and No 3 generators (Fig. 1.13).
2. Differences in the schematic diagrams of generator No 2 and generators No 1 and 3. When the switch is moved from “check” to “enable” with no delay in the “neutral” position, the generator 2 is brought on line without time delay. This leads to increased wear of normally closed contacts in the TKS233DOD unit. The specific design of the electrical systems ensures power supply to each bus from either the APU or engine integrated drive generator.

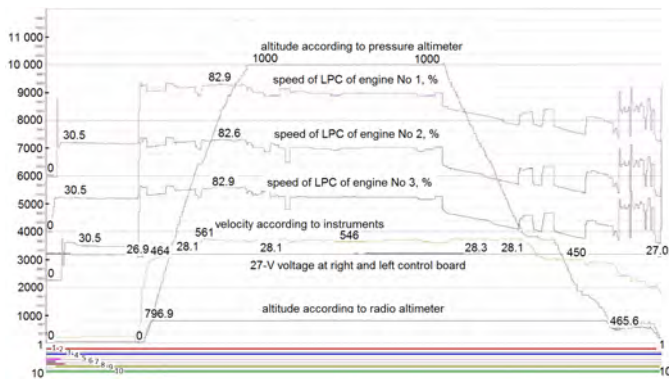
Figure 1.15: Parameters of flight of the Tu-154M No 101 for electrical equipment and engines on April 10, 2010, 7:14 – 8:41 am. LPC = low pressure compressor. Description in Table 1.4 [14, 15].

According to latest research of K. Nowaczyk of the University of Maryland [38, 39], the ATM QAR<sup>3</sup> has recorded a damage to the left engine No 1 and synchronous generator No 1<sup>4</sup>. Both the 115/200 V and 36 V (LSIEC36) of the left grid dropped to zero before the ground impact (Table 1.4).

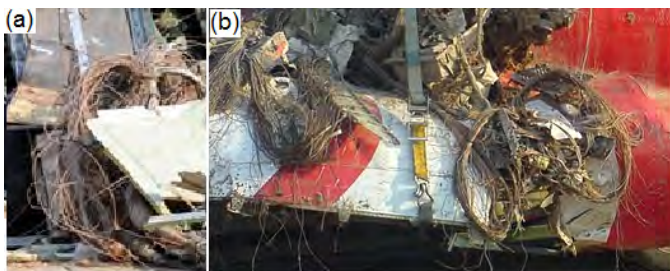
Figure 1.16: Electric wires scattered throughout the Tu-154M No 101 wreckage: (a) at the crash site (beside spare landing gear wheel); (b) hanging from heavy transportation vehicle.

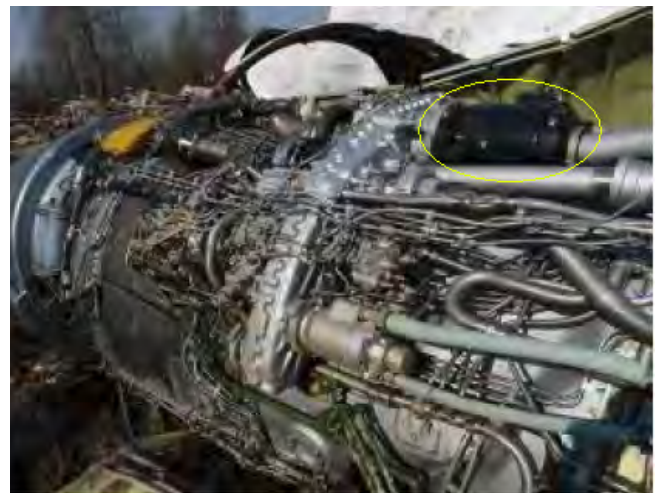
Figure 1.18: Generator GT40PCh6 on No 1 (left) D-30KU turbofan engine. Photo taken between 11 and 13 April 2010 on the crash site [15].

There is no evidence that other than visual inspection of electrical equipment and wiring (Table 1.3) has been done on the crash site [13, 15]. The following statement is given on p. 20/28 of Annexure 4 [15]: *Bundles of electrical wires torn apart (Fig. 1.16). Control boxes deformed. Enclosures of on-board batteries deformed. Some cells leaking.* The report shows photographs of wire bundles, control boxes (Fig. 1.17), synchronous generator GT40PCh6 on the turbofan engine No 1 (Fig. 1.18), batteries and other electrical equipment.

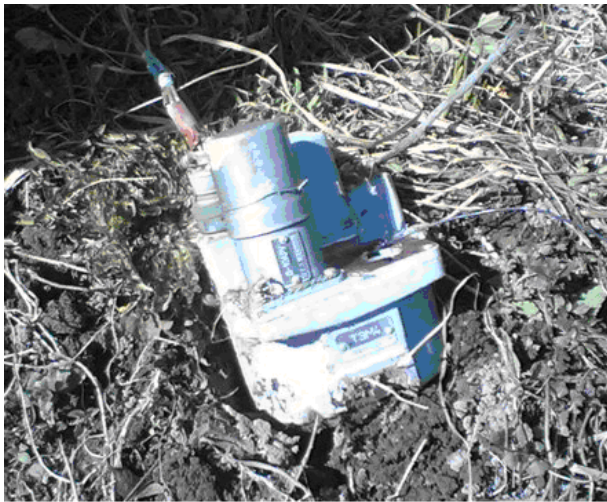
Figure 1.19: Electromagnetic brake TEM-4 for flap control found several meters behind the famous birch tree. Source: <http://www.waronline.org>

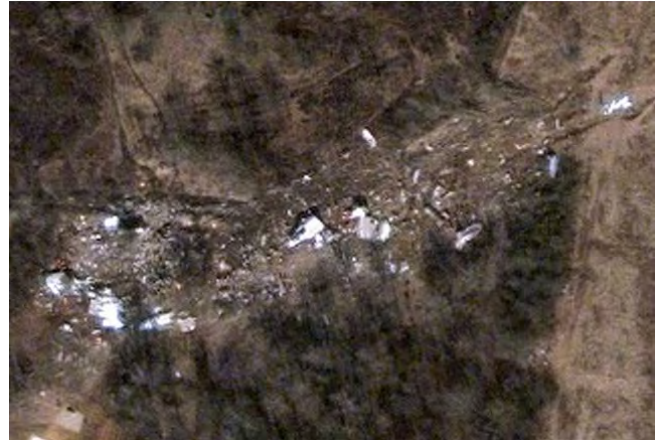
scattering and shape of debris, characteristic opening of the fuselage skin to the outside, dismembered bodies<sup>5</sup>, torn off clothes as well as lack of crater and fuel fire suggest rather explosion in the air above the ground than ground impact [8, 10, 45].

Figure 2.1: Plane crash site on April 12, 2012. Source: Global Digital.

According to official investigations of the Smolensk air crash [13, 29], the cause of disaster was collision of the Tu-154M No 101 with trees while landing in dense fog. At the distance of 855 m before the threshold of runway and 63-m left from its center line, the left wing of the aircraft hit a birch tree with the trunk diameter of about 0.4 m at the height of about 6.6 m [9]. As a result, the tip of the left wing of 6.1-m long between the 27<sup>th</sup> and 28<sup>th</sup> rib has been severed. The first ground impact was 525 m before the threshold of the runway and 105-m left from its center line. The satellite photograph of the crash site is shown in Fig. 2.1. Distribution,

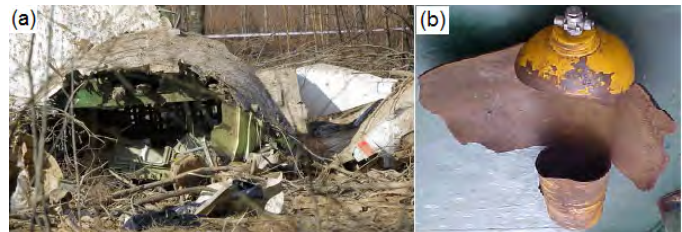
Figure 2.2: Comparison of the fuselage at the crash site on April 10, 2012 with burst gas cylinder: (a) the fuselage looks like burst from inside, the walls are split along its longitudinal axis and open to the outside (<http://krsk.sibnovosti.ru/incidents/103354-podrobnosti-krusheniya-tu-154-v-smolenskoy-oblasti>); (b) burst gas cylinder ([http://www.scubaengineer.com/scuba\\_cylinder\\_videos.htm](http://www.scubaengineer.com/scuba_cylinder_videos.htm)).

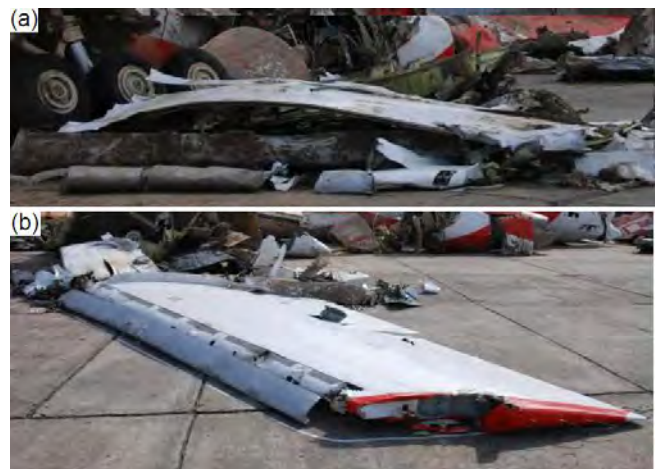
Figure 2.5: Left wing on the wreckage storage site: (a) effect of shock wave penetrating inside the wing [45]; (b) severed tip of the wing [16].

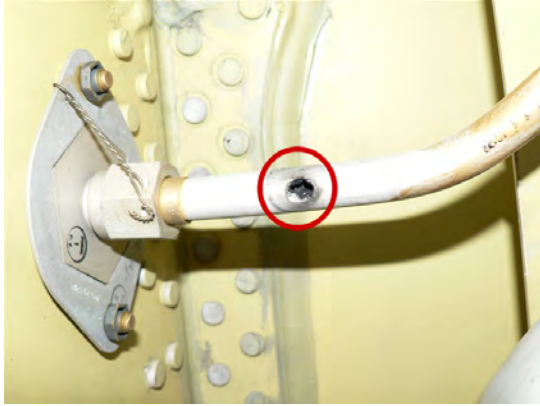
Figure 2.9: Evidence of electrical arcing of the wiring inside the exploded fuel tank of Boeing 727-200, Transmile Airlines, Bangalore, May 4, 2006 [51].

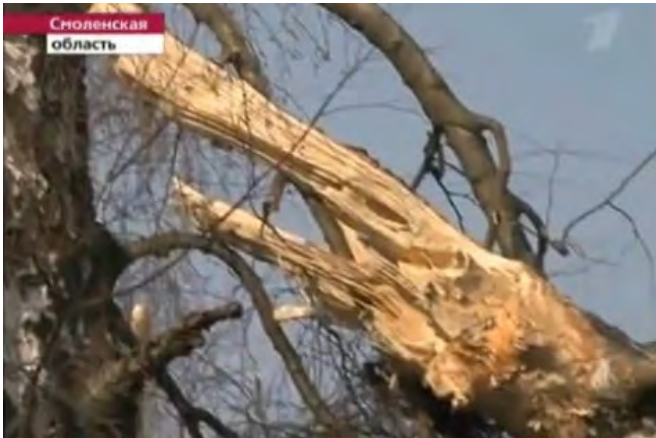
Figure 3.13: Fracture of the trunk of birch tree situated 855 m from the RWY26 runway threshold and 63 m to the left of the glide path. No piece of metal is visible. Photograph taken immediately after crash.

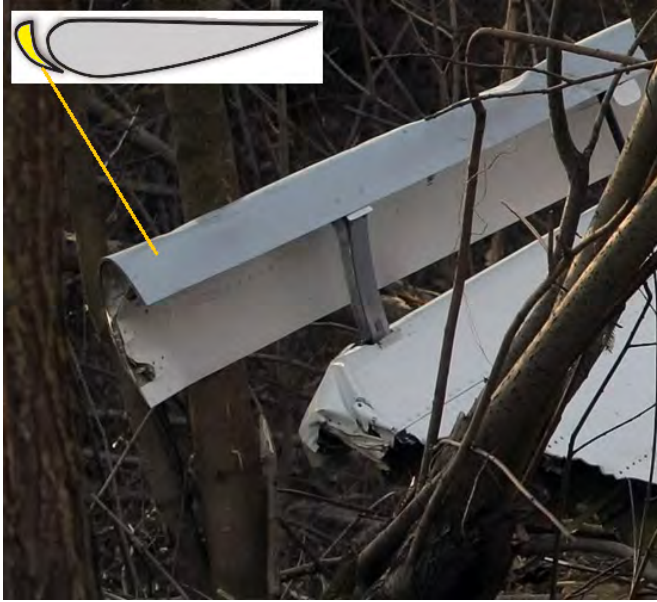
Figure 3.15: Tip of the left wing of the Tu154M No 101 after air crash. The main body of the wing has been cut off while the slat is intact.
