ANALYSIS OF ACCIDENTS OF THE TU-154 AIRCRAFT

Jacek F. Gieras

Abstract

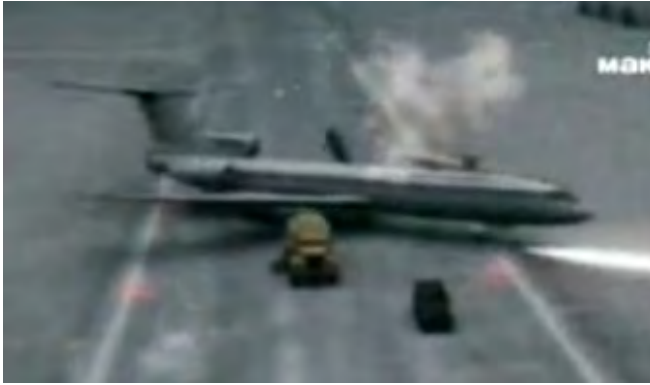
An example of disorder, negligence and lack of responsibility is the accident at Tolmachevo Airport. Omsk, Southwest Siberia on October 11, 1984 (Tab. 2) [5]. One of the controllers had fallen asleep and thus failed to inform the approach controller about the presence of snow vehicles on the runway. On touchdown, the flight crew of the Tu-154B-1 CCCP-85243 saw the array of vehicles and attempted to turn the aircraft, but were unable to avoid the collision. The

plane crashed into the Ural truck and then 200 m down the runway crashed into the KrAZ¹ truck, igniting the 7 t of fuel in each truck and the aircraft's fuel tank (Fig. 1). The plane overturned and broke into pieces, some of which crashed into the UAZ-469² all-terrain vehicle. A catastrophic fracture of the fuel tanks caused burning fuel to leak into the fuselage, incinerating all but one passenger. The cockpit section detached and flew past the burning vehicles. It suffered no major damage, and all four crew members survived, suffering only minor injuries. Four ground maintenance crew were killed instantly inside the vehicles. One survivor in the passenger seat of the UAZ-469 caught on fire, which was extinguished.

Fig. 1. Fatal accident of the Tu-154B-1 CCCP-85243 at Tolmachevo Airport, Omsk, Siberia on October 11, 1984.

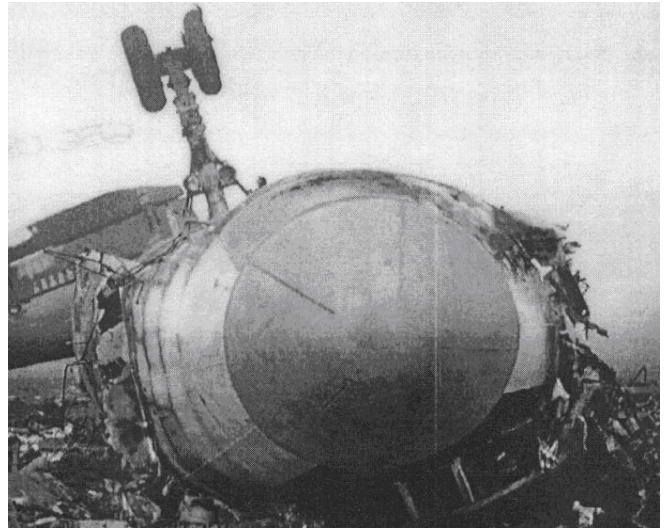
Fig. 3. Wreckage of the Tu-154B UK-85533 at New Delhi Airport on January 19, 1993.

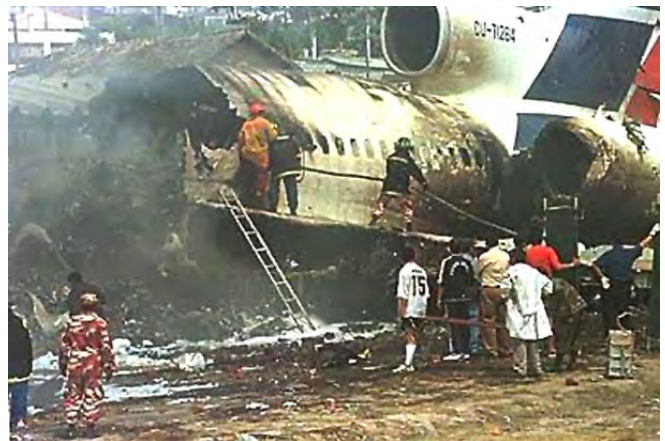
Fig. 4. Tail section of the Tu-154M CU-T1264 at Quito-Mariscal Sucre Airport on August 29, 1998.

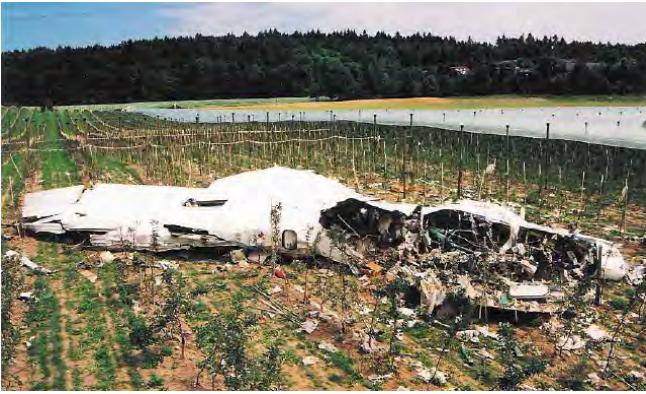
Fig. 5. The forward fuselage section of the Tu154M RA-85816 (Überlingen mid air collision July 1, 2002) found at apple plantation near Brachenreuthe (Lake Constance) [6].

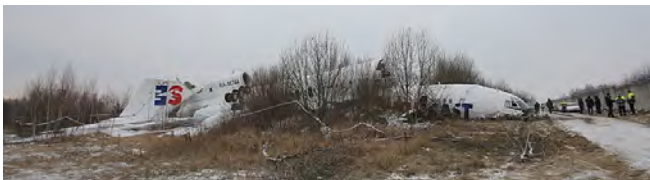
Fig. 6. The Tu-154M RA-85744 with its fuselage broken into three pieces at Domodedovo airport on December 4, 2010 [7].

Even very serious damage to the fuselage not necessarily means large number of fatalities. The Tu-154M RA-85744 departing Moscow Vnukovo Airport on December 4, 2010 (Tab. 7) at a distance of about 80 km from Moscow Domodedovo Airport and at an altitude of 9000 m got fire on engines nr 1 and 3 [5, 7]. The crew decided to divert to Moscow Domodedovo Airport for an emergency landing.

The Tu-154M landed hard and struck a small earthen mound, causing the fuselage to split into three parts (Fig. 6). The crash caused the death to only two people and the injury to 86 people out of 163 passengers and 8 crew members [5].

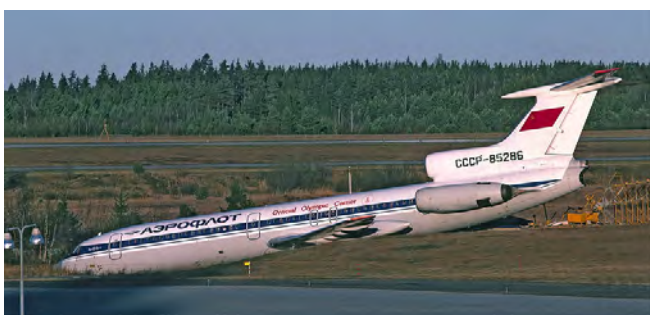
The Tu-154B1 CCCP-85286 (Tab. 8) scheduled from Stockholm to Moscow on November 14, 1978 had reached rotation speed VR when the captain felt firm resistance while trying to lift the nose. The crew decided to abort the take off with only about 500 m of runway left but the speed was too high to stop. The aircraft overran the runway at Stockholm Arlanda Airport, struck an ILS⁴ localizer antenna and crashed after the nose failed to lift up and stopped in an embankment side (Fig. 7) [2-5]. There were 65 passenger and 9 crew members on board [5]. Nobody was killed.

Fig. 7. The Tu-154B1 CCCP-85286 at Stockholm Arlanda Airport on November 14, 1978.

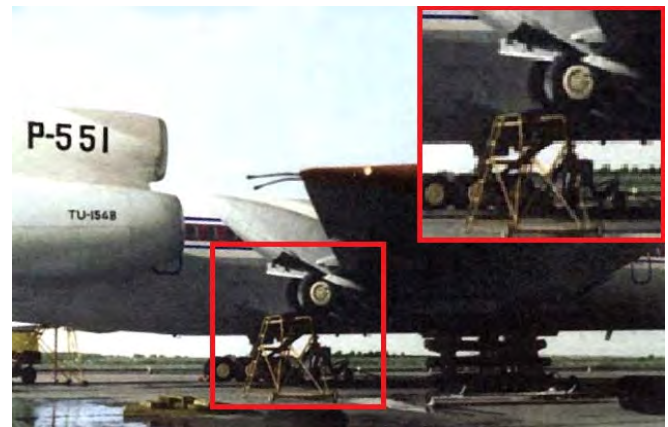
The Tu-154B P-551 passenger aircraft operated by the North Korean airline CAAK departing from Tripoli on June 30, 1979 sustained substantial damage in a landing accident at Budapest-Ferihegy Airport, Hungary (Tab. 8, Fig. 8) [5]. When the pilot realized that the aircraft would undershoot, he raised the nose without applying power. At a speed of 256 km/h the aircraft stalled and landed hard. The right landing gear collapsed and the right wing struck the ground

causing substantial damage to the wing structure [2-5]. There were no fatalities.

Fig. 8. The Tu-154B P-551 with damaged right landing gear and wings at Budapest-Ferihegy Airport on June 30, 1979.

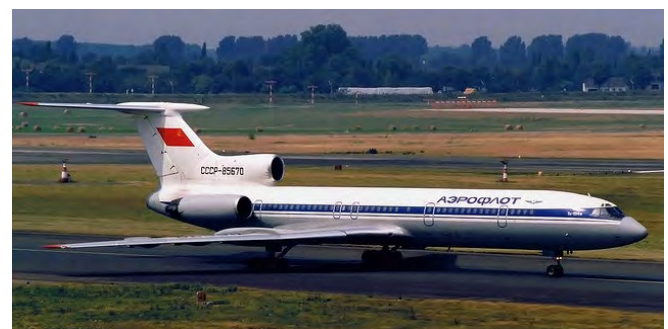
The Tu-154M CCCP-85670 (Fig. 9) while approaching Zurich Kloten Airport on August 23, 1992 (Tab. 10) in conditions of heavy rain and turbulence abandoned the landing and a *go-around* procedure was initiated [3-5]. The aircraft lost some height and collided with a 6 m high antenna, located 650 m from the runway. The inner flaps on

the right wing were damaged substantially and the crew could only carry out a right hand turn instead of a left one as told by ATC⁵. A safe flapless landing was made with no injuries to 136 occupants and 9 crew members. The probable cause could be too late initiated *go-around* and incorrect assessment of the weather conditions by the crew.

Fig. 9. The Tu-154M CCCP-85670 that collided with antenna at Zurich Kloten Airport on August 23, 1992.

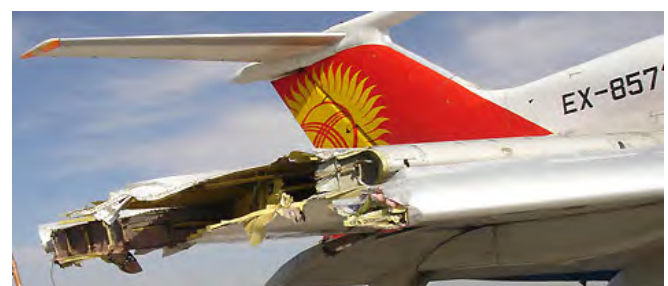
Fig. 10. The Tu-154M EX-85718 with damaged wing at Manas Airport, Bishkek, Kyrgyzstan on September 26, 2006.

off. The departing and accelerating aircraft's right wing passed under the outer portion of the KC-135's left wing tip, but clipped and eventually destroyed the No 1 engine (left outboard engine) and a portion of the wing. **Despite losing up to 2,5 m of its outer right startboard wing in the collision (Fig. 10 and Fig. 11), the Tu-154, with 52 passengers and nine crew, became airborne and was able to take off, reach an altitude of about 200 m and circled once before returning to the airport for a successful emergency landing.** The flight of the Tu-154M with broken wing lasted several minutes.

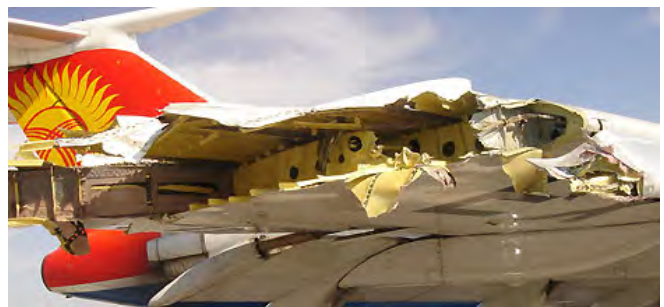
The accident resulted in heavy damage to both aircraft, but left no casualties and victims. The KC-135 caught fire and sustained extensive damage. US military personnel, who use Manas Bishkek international airport as a technical support base for operations in neighbouring Afghanistan, extinguished the fire without resorting to airport ground services [2-5].

Fig. 11. Details of the damaged right wing of the Tu-154M EX-85718, which struck the parking KC-135R tanker.

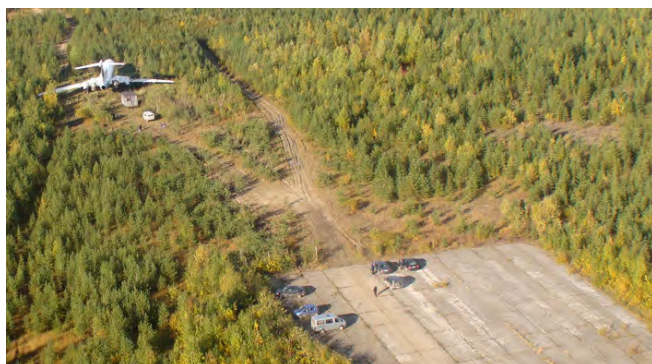
The Tu-154M, RA-85684, Alrosa Mirny Air Enterprise performing flight 6R-514 from Polyarny to Moscow Domodedovo on September 7, 2010 (Tab. 13) with 72 passengers and 9 crew, was enroute at 10600 m when the aircraft about four hours after the start suffered a complete failure of electric power resulting in stoppage of fuel pumps and loss of navigation devices [5, 8]. When the plane descended under low clouds near Izhma, Komi, the commander has noticed an old airfield. The city emergency services of Izhma were advised the airplane might approach their abandoned airfield. The runway was only about 1200 m long and designed for light military aircraft, closed in 2003 and now only used as a helicopter platform. The airfield Izhma is located 3 km northeast of Izhma and 180 km north of town Usinsk. The crew was able to put the airplane down onto Izhma's abandoned runway. The impact was damped by young trees, which have grown since the airfield was closed. Because of the electric power failure, the Tu-154M could not brake on the 1200 m runway and overrun about 200 m out in the woods (Fig. 12). Although the flaps are driven by hydraulics, the flap control switches are electric. The airplane received substantial damage, but none of 72 passengers and 9 crew members suffered any

Fig. 12. Emergency landing of the Tu-154M RA-85684 at old airfield in Izhma, Komi Republic, Russia, Sept. 7, 2010 [8].

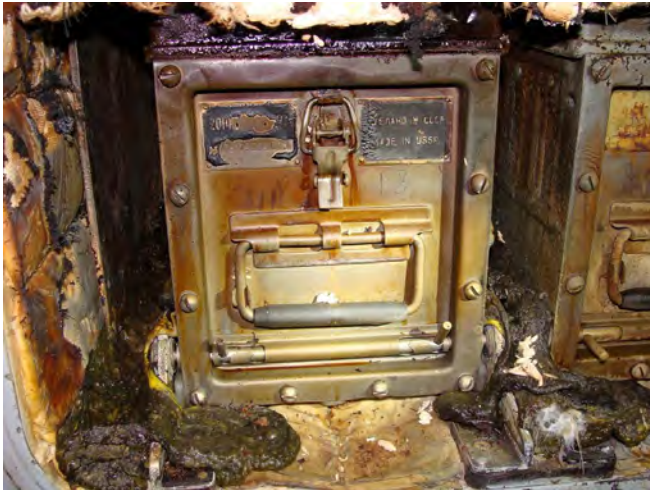
According to investigations, this incident occurred as a result of the failure of the power supply 27 V DC due to thermal damage, i.e., thermal runaway⁶ of the on-board

20NKBN-25 nickel-cadmium battery No 1 (Fig. 13) supplying the left DC grid [8, 9, 10,]. It has been found that batteries were used in violation of the maintenance manual. Similar problems were encountered on the Boeing 787 *Dreamliner* flights in Japan and Boston in January 2013 when the lithium-ion batteries got overheating.

Overheated 20NKBN-25 batteries of the Tu-154M RA-85684 failed taking out the entire electric system and caused the failure of all attached systems including navigation and radio equipment as well as all fuel pumps.

Fig. 13. The damaged 20NKBN-25 battery No 1 in the battery compartment of the Tu-154M RA-85684, which landed at Izhma airfield September 7, 2010 [8].

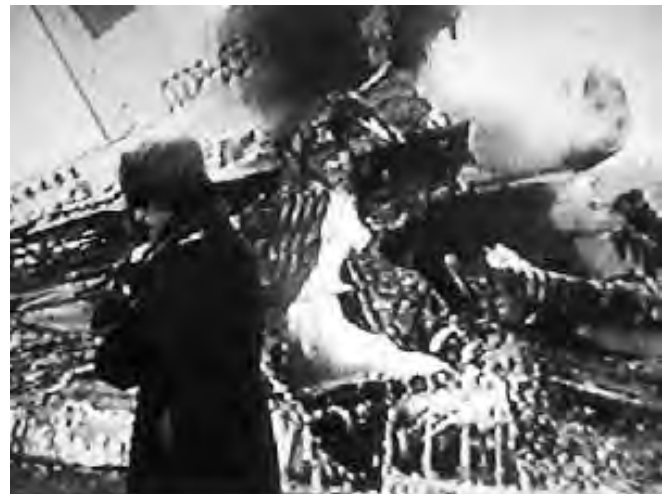
Fig. 18. Destroyed tail section of the Tu-154B2 CCCP-85413 at Veshchevo air base 100 km northwest of St. Petersburg, March 8, 1988.

The Tu-154B2, CCCP-85413 (Tab. 3) departing from Irkutsk to Leningrad on March 8, 1988 with 170 passengers on board was hijacked by Ovechkin¹⁰ family (11 people) [2-5]. The hijackers wanted the aircraft to divert to London, but the pilots managed to convince them they would have to refuel to reach that destination. They diverted to Veshchevo, telling the hijackers this was actually an airfield in Kotka, Finland. The aircraft was stormed by Soviet security forces. A bomb exploded causing severe damage to the tail of the aircraft (Fig. 18). Five of the hijackers, 3 passengers and one female flight attendant have been killed [2-5].

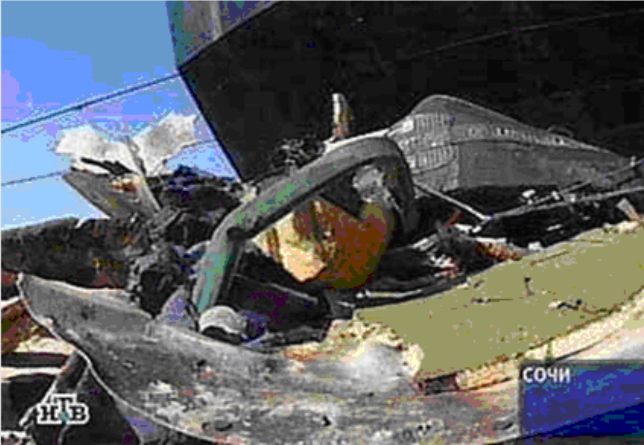
Fig. 19. Remnants of the Tu-154M RA-85693 lifted by a rescue vessel.

On October 4, 2001 the Tu-154M RA-85693 of Siberia Airlines departed Tel Aviv for a scheduled flight 1812 to Novosibirsk (Tab. 6) [2-5]. It proceeded at an altitude of 11000 m at speed 850 km/h over the Black Sea.

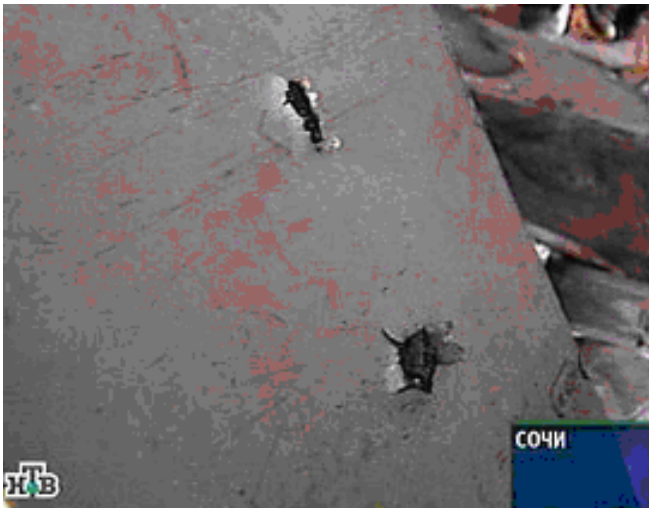
Fig. 20. Holes found in the fuselage and other fragments of the Tu-154M RA-85693 can be identified as a shrapnel trace of anti-aircraft missiles.

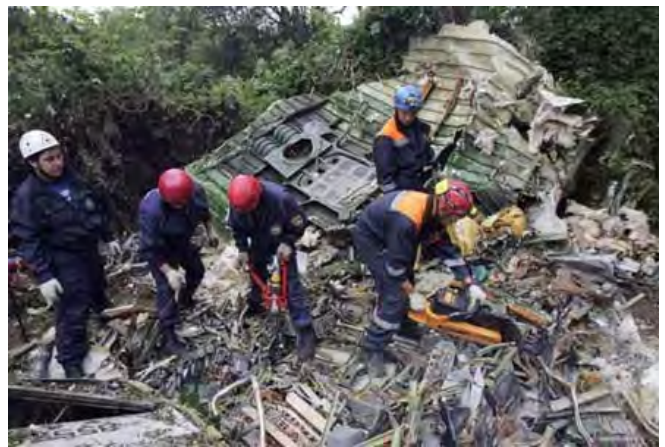
On August 28, 2004 the Tu-154B2 RA-85556 operated by Siberia Airlines departed Moscow Domodedovo Airport for a scheduled passenger flight to Sochi (Tab. 6) [2-5]. About 1 h and 20 min after takeoff the aircraft disappeared from the radar. Wreckage was located several hours later near Millerovo, 138 km off the city of Rostov-on-Don (Fig. 21 to Fig. 24). All the 46 passengers and crew-members on board were killed. Traces of the explosive Hexogen (RDX) were found in the remains of the plane. Recordings from “black boxes” indicate that there was no evidence of a hijacking attempt or any other disturbance before the explosion aboard the aircraft. The subsequent investigation has found out that the bombs were triggered by two female Chechen suicide bombers.

Fig. 21. Remnants of the Tu-154B2 RA-85556 on the crash site.

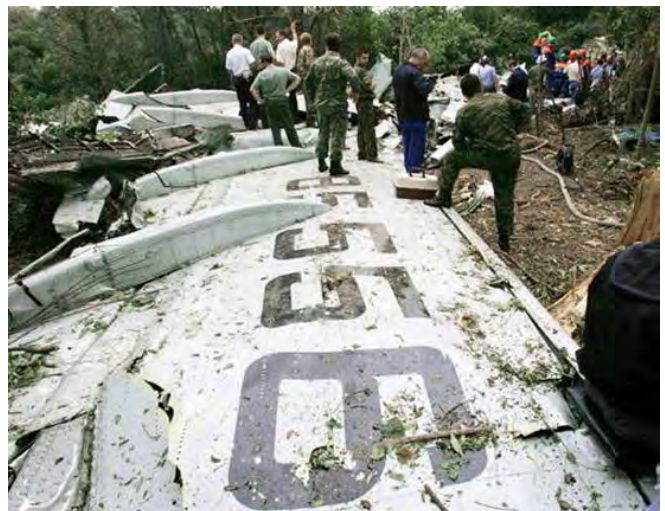
Fig. 22. Left wing of the Tu-154B2 RA-85556 on the crash site.

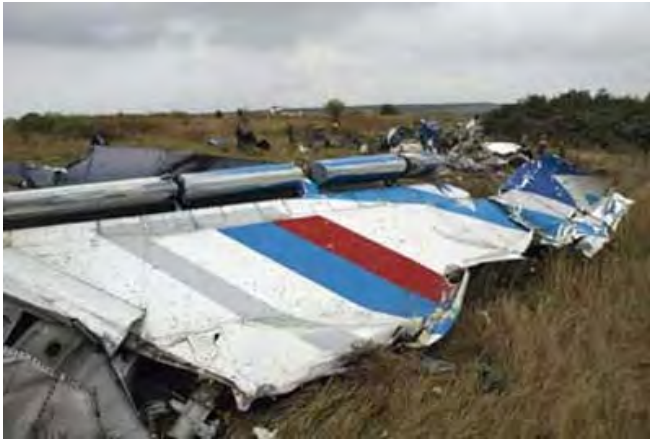
Fig. 23. Rudder of the Tu-154B2 RA-85556 on the crash site.

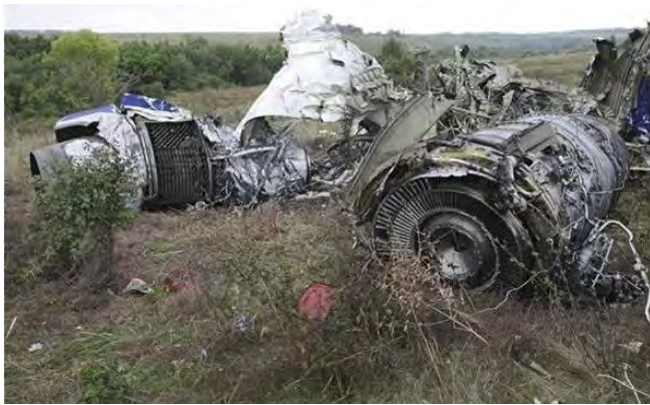
Fig. 24. Turbofan engines Kuznetsov NK-8-2 of the Tu-154B2 RA-85556 on the crash site.

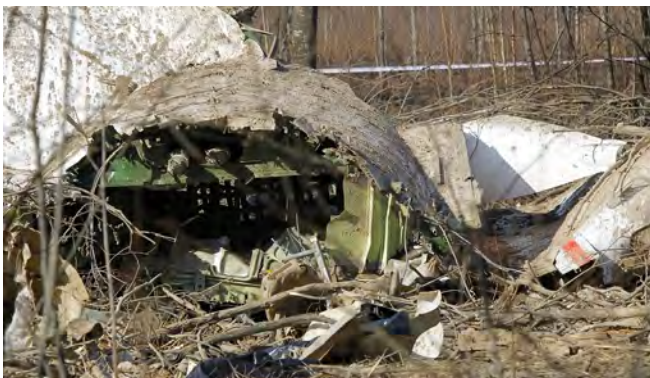
- mid section of the fuselage with its walls split in longitudinal direction and open to the outside (Fig. 25);
- separation of the rear section of the fuselage around the frame No. 65 due to action of axial force (Fig. 26).

Fig. 25. Split skin of the fuselage (resting upside down) of the Tu-154M PLF 101 along its longitudinal axis and rolled out.

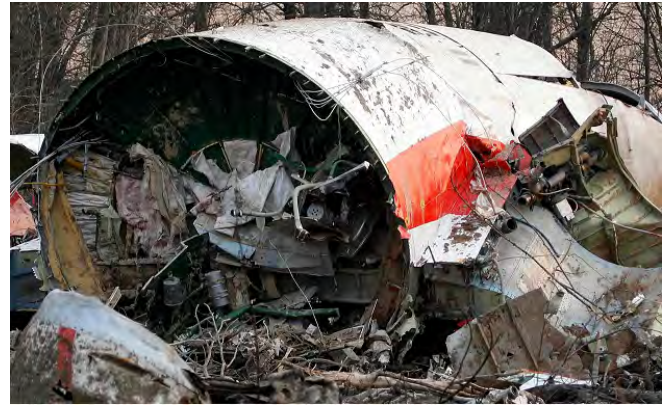
Fig. 26. Rear part of fuselage of the Tu-154M PLF 101 torn around the frame No. 65 with broken bolts.

In the case of explosion in a thin-wall cylindrical vessel, its closed ends can be also torn down. Typical example of such explosion is rupture of truck tank with liquefied petroleum on February 20, 2012 in Northern China (Fig. 30). Inner forces in longitudinal direction have torn the closed ends off the cylindrical section. Similar action of inner axial forces can be observed when the rear portion of the fuselage is separated from the mid fuselage, e.g. Fig. 26.

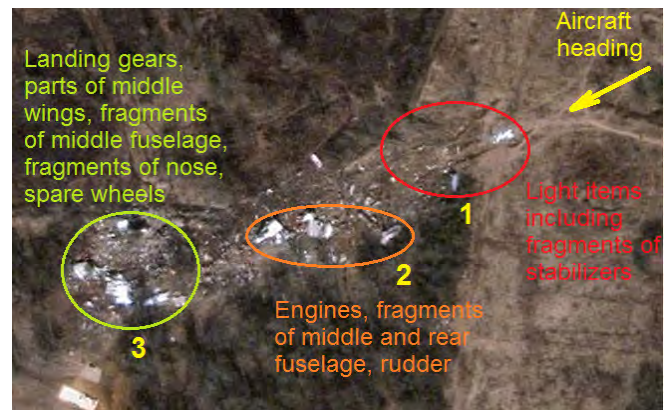
Fig. 27. The Tu-154M PLF 101 wreckage trail plot grouped by location of parts of the aircraft: (1) light items including fragments of stabilizers; (2) engines, fragments of middle and rear fuselage, rudder; (3) landing gears, parts of middle wings, fragments of middle fuselage, fragments of nose, spare wheels.

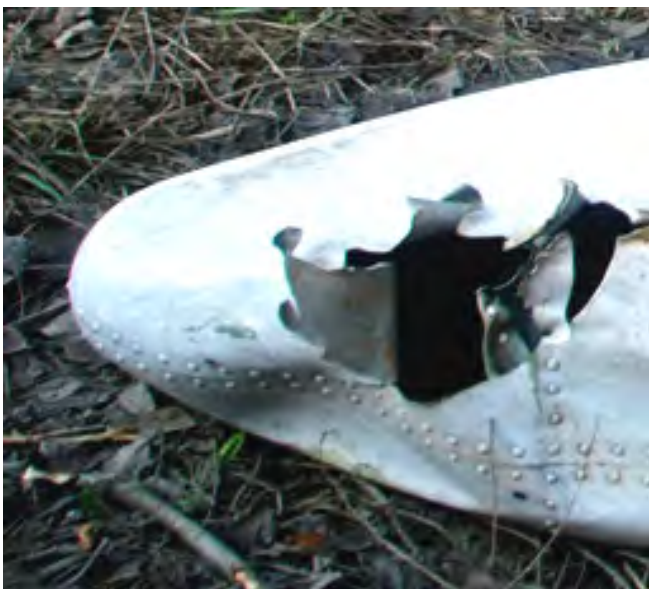
Fig. 33. Petaled hole with rolled edges in a wing part (probably wing fairing) of the Tu-154M PLF 101 found near crash site. This hole is not a full evidence of explosion because no other symptoms of explosion as, for example, tensile rivet failure, staining, impact craters, etc., are visible. Source: http://inapcache.boston.com/universal/site_graphics/blogs/bigpicture/poland_04_12/p03_22969387.jpg

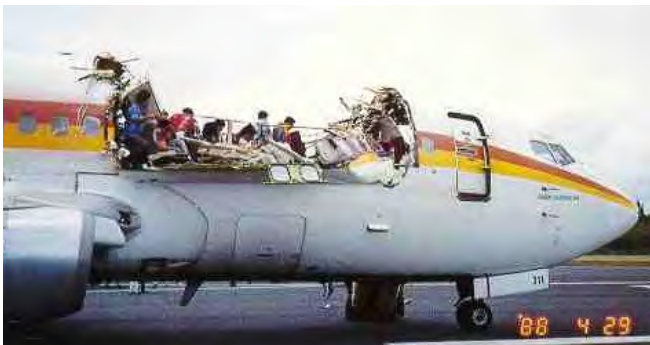
Fig. 41. Open fuselage of the Boeing 737 Aloha Airlines, Flight 243, April 28, 1988 due to cracks along riveted paths. Source: <http://deicinginnovations.com/wp-content/uploads/2012/07/Aloha.jpg>

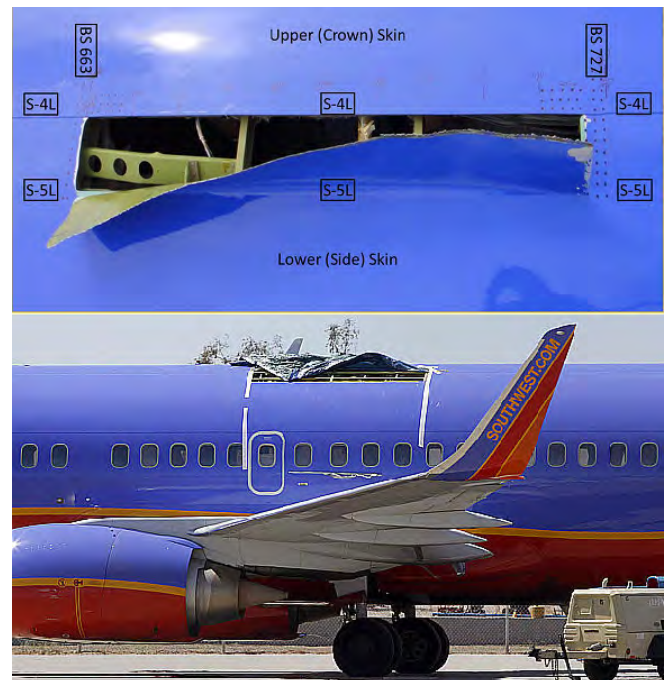
Fig. 42. Roof of the Boeing 737-300 Southwest Airlines Flight 812 with 1.5-m long rip, April 1, 2011. Source: <https://www.scientificamerican.com/article.cfm?id=southwest-airplane-aluminum-cracks>.

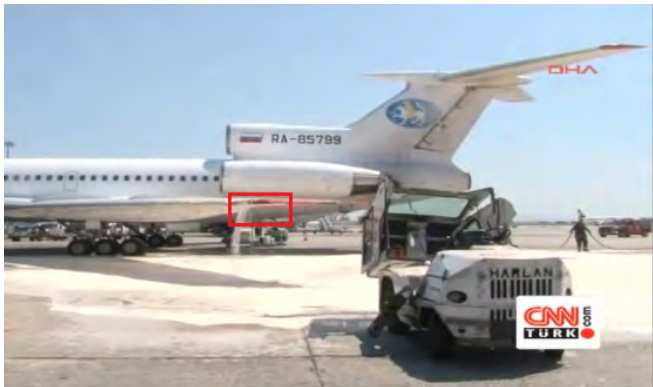
Fig. 44. Tu-154M RA-85799 and luggage truck after collision at Istanbul Ataturk airport on July 27, 2011. Source: <http://www.euromag.ru/turkey/11679.html>.

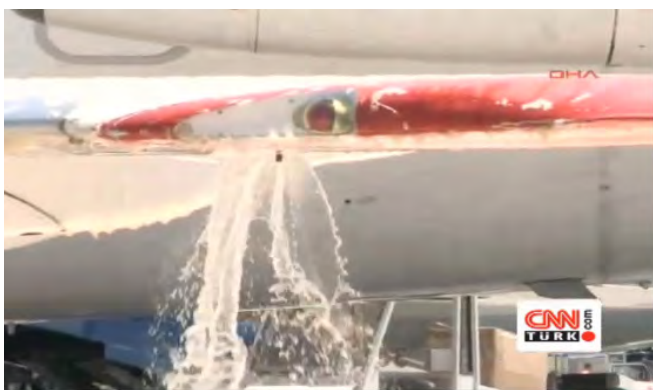
Fig. 45. Fuel leakage from the damage tip wing of the Tu-154M RA-85799 at Istanbul Ataturk airport on July 27, 2011. Source: <http://www.euromag.ru/turkey/11679.html>

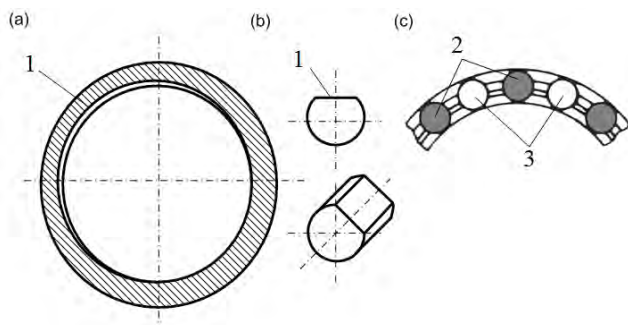
Fig. 48. Destruction of inter-shaft bearing (part 2 in Fig. 47): (a) outer race of bearing, (b) roller of bearing, (c) cage with incomplete rollers. 1 - wear of material, 2 - rollers, 3 - no rollers.
