# SELECTED TECHNICAL ASPECTS OF TU-154M SMOLENSK AIR CRASH ON APRIL 10, 2010

JACEK F. GIERAS

**ABSTRACT.** This is a collection of reports that consists of three parts. The author is a Professor of Power Electrical Engineering, so he focuses on the Tu-154M power electric system and all aspects of the air crash that relate to electrical equipment and wiring.

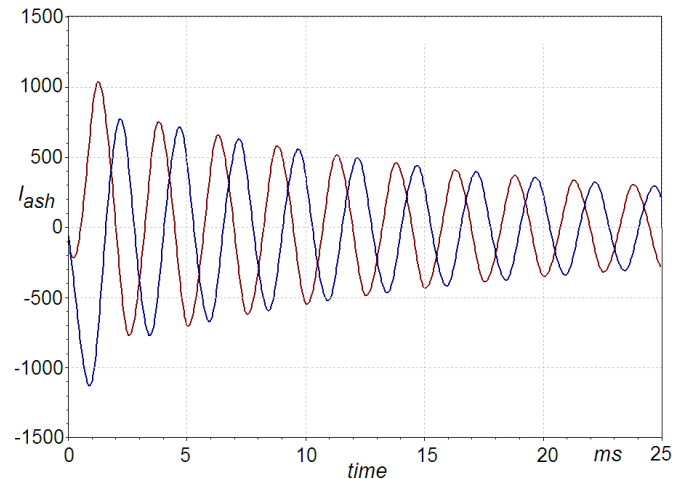
Figure 1.11: Armature current  $I_{ash}$  at two lines-to-neutral short circuit of GT40PCh6 synchronous generator. The peak short-circuit current is  $I_{ashp} = -1130$  A corresponds to  $t = 0.6$  ms [20].

Short-circuit currents can exceed more than 11 times the nominal current. The most dangerous is two lines-to-neutral short circuit (Fig. 1.11).

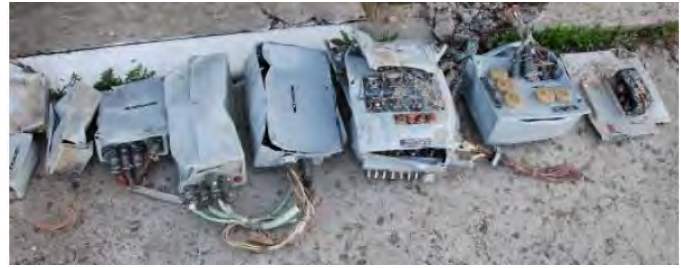
Figure 1.17: Junction and control boxes of electrical installation. Photo taken at the site of wreckage storage [16].

There is no evidence that other than visual inspection of electrical equipment and wiring (Table 1.3) has been done on the crash site [13, 15]. The following statement is given on p. 20/28 of Annexure 4 [15]: *Bundles of electrical wires torn apart (Fig. 1.16). Control boxes deformed. Enclosures of on-board batteries deformed. Some cells leaking.* The report shows photographs of wire bundles, control boxes (Fig. 1.17), synchronous generator GT40PCh6 on the turbofan engine No 1 (Fig. 1.18), batteries and other electrical equipment.

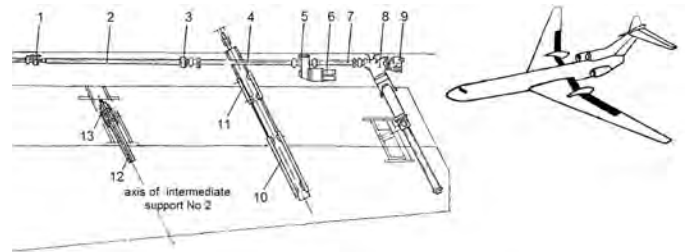
Figure 1.20: Location of electromagnetic brake TEM-4 for flap control. 1,3 – bracket, 2,4 – transmission shaft, 5 – reducer, 6 – electromagnetic brake TEM-4, 7 – cardan joint, 8 – lift for the outer flap, 9 – mechanism of limit switches with sensor, 10 – rail of external deflector, 11 – carriage of external deflector, 12 – rail of deflector, 13 – intermediate carriage of deflector [48].

The object found at the crash site several meters behind the famous “armored” birch three [13] and shown in Fig. 1.19 has been often incorrectly identified as a fuel pump. However, this is the electromagnetic brake TEM-4 used for control of flaps (Fig. 1.20).

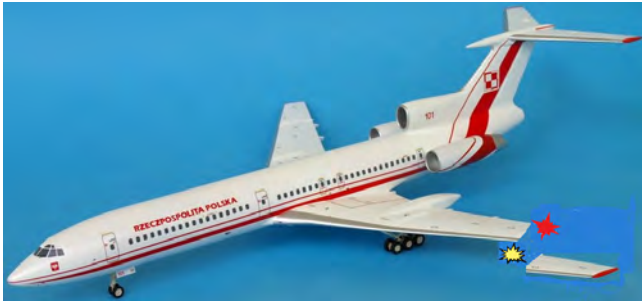
Figure 2.3: Hypothesis of explosion in the left wing.

many knots [9] is rather impossible [1, 2], the problem should be stated in opposite way: *The burst of the left fuel tank No 3 caused the lost of the left portion of the wing.*

According to [45], the Tu-154M No 101 crash was due to two explosions in the air: one on the left wing (Fig. 2.3) and the second inside the fuselage. An *explosion is defined as an event leading to increase of pressure due to high explosives, combustion of dust, mist or gas in the air, loss of containment in high pressure vessels, nuclear reaction, etc.* [3]. Huge amount of small plane's pieces and their location on the ground (Fig. 2.1), fuselage split along its longitudinal axis (Fig. 2.2), rivets torn out<sup>6</sup>, lack of crater, etc., exclude the crash caused by the mechanical impact.

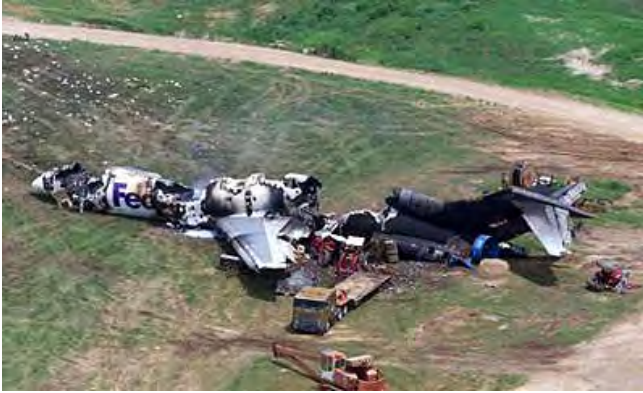
Figure 2.6: Wreckage of the Boeing 727-232F FedEx flight 1478 at Tallahassee Regional Airport (TLH). Source: <http://www.aero-news.net/images/content/commair/2003/fedex727crash0726b.jpg>

Very similar case to Tu154M No 101 air crash took place on July 26, 2002, about 05:37 eastern daylight time (EDT) at the Tallahassee Regional Airport (TLH), Tallahassee, FL [12]. The Federal Express (FedEx) flight 1478, a Boeing 727-232F, N497FE, struck trees on short final approach and crashed short of runway 9. The airplane collided with trees in a right-wing-low, slightly nose-up attitude during the approach to runway 9, then impacted the ground, coming to rest on a heading of  $260^\circ$  about 474 m (1556 feet) west-southwest of the runway (Fig. 2.6). A postimpact fire ensued; however, the three flight crewmembers exited the airplane through the captain's side sliding cockpit window before the fire reached the cockpit [12]. The crash site shown in Fig. 2.6 cannot be compared to that shown in Figs 2.1 and 2.2a. The Tu-154M is conceptually similar to the Boeing 727, e.g., both aircraft use a rear engine T-tail configuration, S-duct for the middle (No 2) engine, similar leading edge sweep of wings, etc.

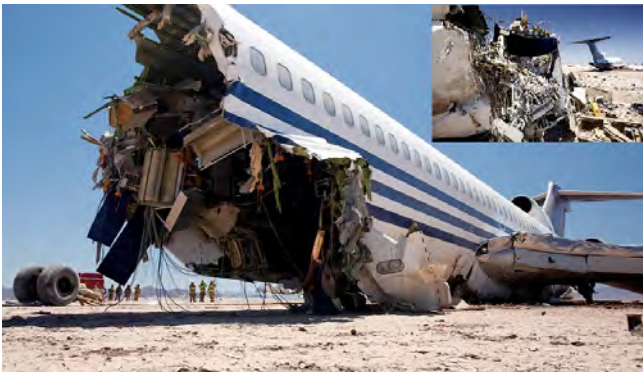
Figure 2.7: Boeing 727 after crash on Sonoran Desert with its fuselage ripped in two [47]. Compare with Fig. 2.1 .

Recent full-scale experiment<sup>9</sup> with a 170-seat Boeing 727 passenger aircraft in a remote and unpopulated Sonoran Desert of Baja California, Mexico, has shown no fragmentation of the aircraft into small pieces under ground impact (Fig. 2.7) [47]. The objective was to recreate a serious passenger jet crash landing, so that scientist and engineers could study the impact of air crashes on the human body and aircraft structure. The pilot parachuted out of the cockpit at 762 m before the plane was plunged into the ground via remote-control by a pilot in a following Cessna. As the plane hit the ground with its speed of 225 km/h, the fuselage was torn in two with the nose embedded in the ground. Crash investigators predicted that 78% of passengers on board would have survived such ground impact. The TU-154M is a Russian copy of Boeing 727.

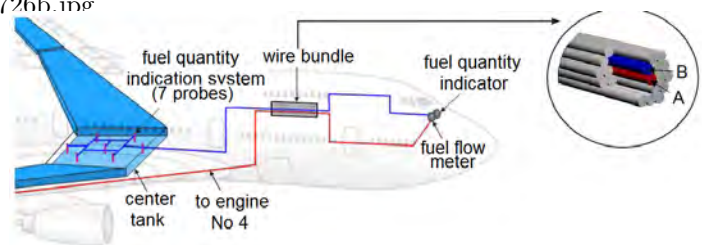
Figure 2.8: Wiring configuration on the Boeing 747. Investigators suspect that high voltage from the fuel flow meter A passed to the fuel quantity indication system (FQIS) B because of a short circuit in the wire bundle [34].

In older (and also many new) types of passenger aircraft the electric wires belonging to different electric circuits are laid in common bundles [18, 53]. It is economical solution, which reduces the cost of electrical wiring. On the other hand, aging and deterioration of insulation, wire overheating, short circuit or electric arcing in one electric circuit can make damage to insulation and short circuit of wires belonging to other electric circuits. Thermal protections are sometimes not reliable. For example, short circuit in a bundle of electric wires caused ignition of fuel-air mixture in the center wing tank (CWT) of the Boeing 747-131, flight TWA 800 on June 17, 1996 (Fig. 2.8). Burst of CWT led to destruction of the aircraft over the Atlantic Ocean [34].

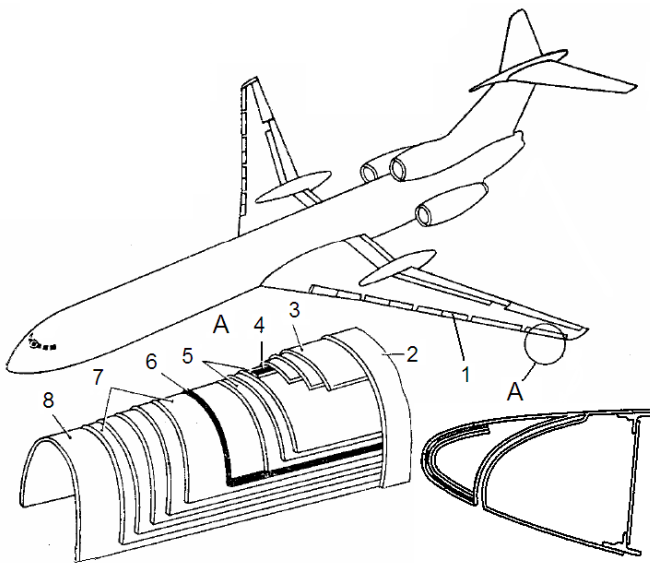
Malfunction of anti-ice electric heating system installed in slats (Fig. 2.13) could lead to local temperature rise in the tank wall and create friendly conditions for fuel ignition by sparks or arcing. Fuel vapor *auto-ignition* due to local hot spot in fuel tank, or temperature rise due to malfunction of anti-ice electric system or other electrical equipment/wiring is rather impossible, since the auto-ignition temperature of Jet A-1 fuel is 210°C (Table 2.3). More realistic is *electrostatic charge build-up* (ECA) due to fuel flow and hazardous electric potential level inside the tank.

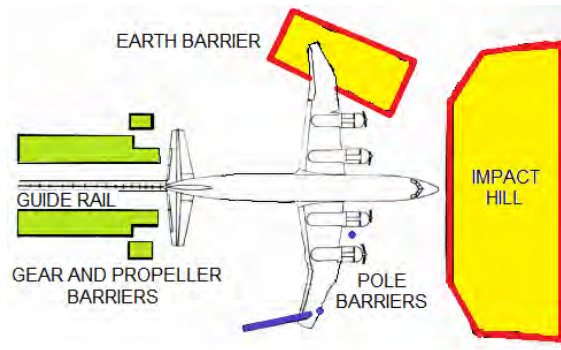
Figure 3.1: DC-7 test site and wing impact sequence. Telephone poles have been marked with blue color [40].

- The first barrier was the landing gear barrier (Fig. 3.10a).
- All four propellers were broken as a result of hitting the propeller barriers (Fig. 3.13b). All four engine mounts failed.
- The gear barrier torn out the right main landing gear, which struck the right horizontal stabilizer (Fig. 3.10c).
- The impact with the outer pole (Fig. 3.1) cut off the right wing approximately 3.66 m (12 feet) from the tip. The main tank No 4 (Fig. 3.11) was ruptured by the pole.

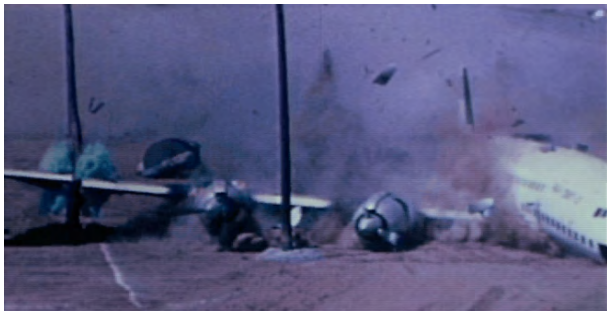
Figure 3.2: LC-1649 full-scale dynamic crash test. Out-board pole impact [41].

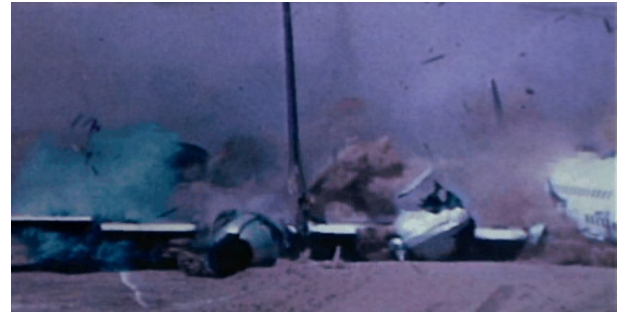
Figure 3.3: LC-1649 full-scale dynamic crash test. In-board pole impact [41].

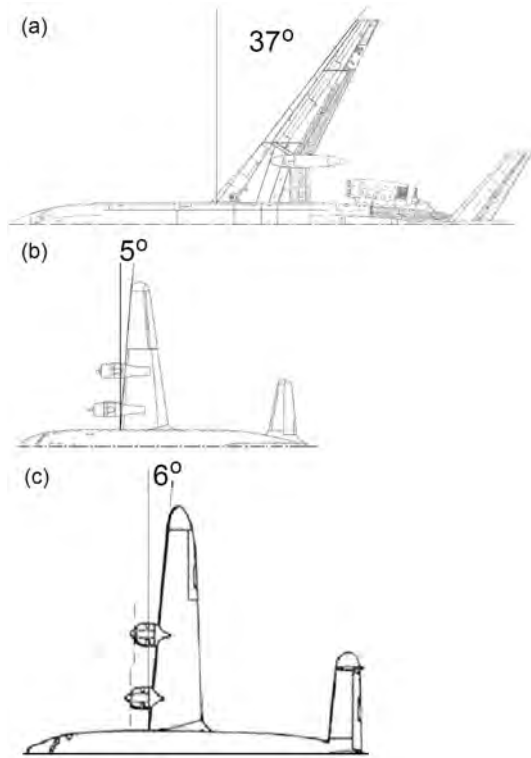
The *leading edge sweep*<sup>13</sup> of the wing (Fig. 3.9) is about 37° for the Tu-154M, about 5° for the DC-7 and about 6° for the LC-1649 aircraft (Table 3.1). It is easier to cut a pole/tree barrier by a wing with large leading edge sweep angle (Tu-154M) than by a wing almost perpendicular to the center line of the fuselage (DC-7, LC-1649). For example, to decrease the amount of force required in a guillotine cutter and to cut the material more swiftly, the blade is angled [22]. This angle is referred to as the *shear angle* or the *rake angle of a shear*<sup>14</sup>. The shear angle decreases the force, but increases the stroke [26].

Figure 3.9: Leading edge sweep of wings of (a) Tu-154M, (b) DC-7 and (c) LC-1649 aircraft.

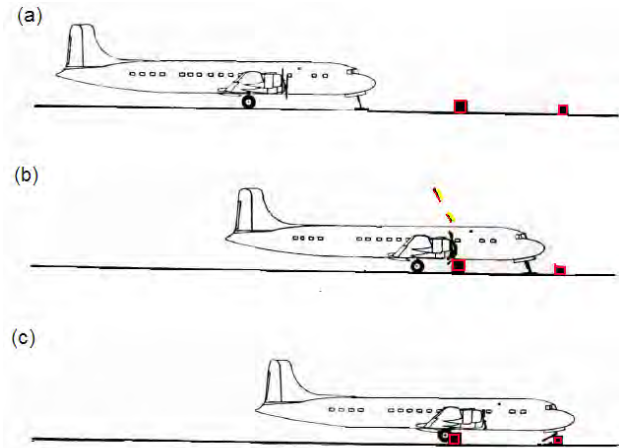
- The left landing gear was broken (Fig. 3.10) and caused the engine No 2 (Fig. 3.12) to roll under the left wing.
- The right landing gear was also broken and severed the right vertical fin of the right horizontal stabilizer.

- The propeller of the engine No 2 (Fig. 3.12) was sheared off by the landing gear barrier.
- The engines No 1, 3, and 4 (Fig. 3.12) and their propellers were intact, with the exception of one propeller blade of the engine No 3, which was sheared off by the right main gear barrier (Fig. 3.10).

- The rail guide shoe was broken off on impact with the nose gear barrier (Fig. 3.10c). The gear strut was forced into the forward fuselage.
- After passing through the gear barriers and hitting the earth, propellers on engines No 1, 3, and 4 (Fig. 3.12) lost their blades. A tear in the wing structure adjacent to the engine nacelles became visible.

Figure 3.10: Gear and propeller impact sequence: (a) aircraft approaching gear and propeller barriers; (b) impact with propeller barrier; (c) impact with main and nose landing gear barrier [40].

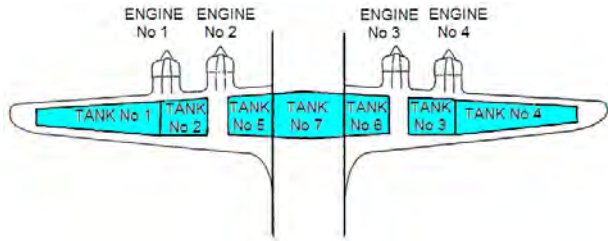
- The left wing struck the earthen barrier and started to separate from the fuselage at the wing root, while the right wing hit the poles.
- The first pole nearly sheared off the outer panel of the right wing and opened up the fuel tank No 4 (Fig. 3.12) about 7.6 m (25 feet) from the tip (Fig. 3.2). The second pole cut into the wing and the No 3 fuel tank between the engines No 3 and No 4 (Fig. 3.12). The portion of the right wing inboard of the No 3 engine nacelle remained attached to the fuselage throughout the crash (Fig. 3.3).

Figure 3.12: LC-1649 fuel tank and engine locations [41].

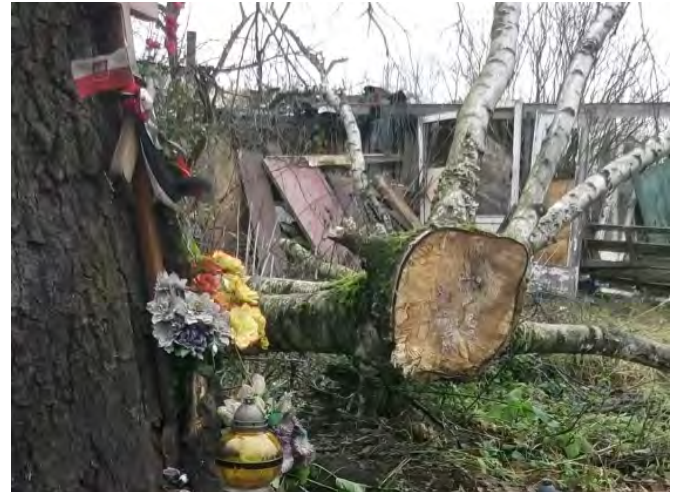
There is also no evidence of detailed investigation of the birch tree and separated tip of the left wing. The photograph taken immediately after the crash (Fig. 3.13) does not show any pieces of metal embedded in the wood. The photographs taken by S. Amelin also do not show chunks of metal. Recently, the part of the trunk with fracture has been cut off (Fig. 3.15).

Figure 3.14: The part with fracture of the birch trunk was cut off probably in September 2012. Photograph uploaded on November 14, 2012. Source: <http://imgsrc.ru/para-moto1/30127119.html>.
