ANALYSIS OF ACCIDENTS OF THE TU-154 AIRCRAFT

Jacek F. Gieras

Abstract

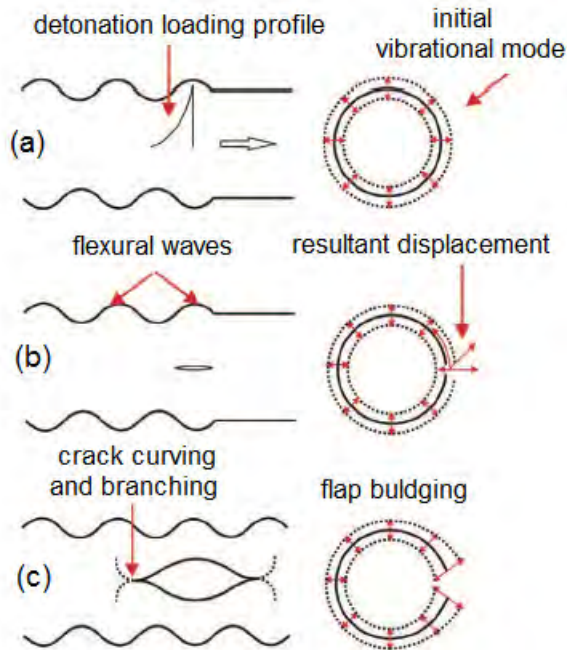
Fig. 28. Cyclic crack growth in a tube: (a) moving detonation front; (b) formation of flexural waves; (c) flap bulging, curving, and branching [20].

One of the most important questions that arouse during the accident investigation is whether the type of accidental combustion can be deduced from the fracture patterns [20]. It has been recently proved that at high pressure level a major portion of crack growth under the influence of fluctuating stresses is periodic (Fig. 28) [20]. The passage of detonation front results in a pattern of fluctuating hoop strains. Large tensile stresses develop in the bulged region in the axial direction of the tube causing a rupture of the tube (Fig. 28) [20]. Examples of confined ruptures of

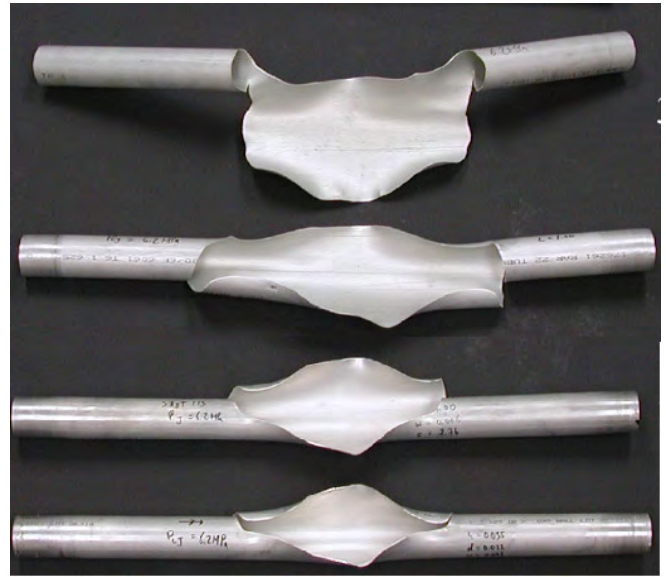
Fig. 29. Examples of confined ruptures of experimental aluminum tubes under internal gaseous detonation [28].

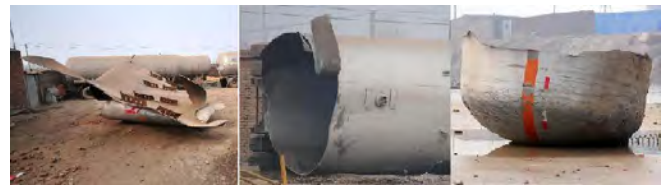
Fig. 30. Explosion of liquefied petroleum in truck tank, Xigu District of Lanzhou, Gansu Province, China on February 20, 2012. Source: http://www.china.org.cn/photos/2012-02/21/content_24689788.htm

In the case of explosion in a thin-wall cylindrical vessel, its closed ends can be also torn down. Typical example of such explosion is rupture of truck tank with liquefied petroleum on February 20, 2012 in Northern China (Fig. 30). Inner forces in longitudinal direction have torn the closed ends off the cylindrical section. Similar action of inner axial forces can be observed when the rear portion of the fuselage is separated from the mid fuselage, e.g. Fig. 26.

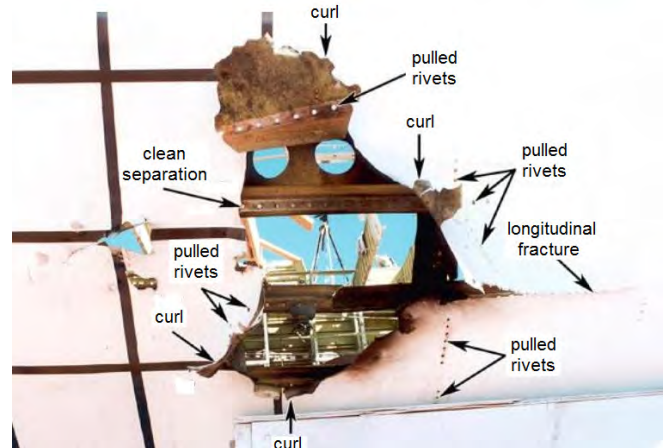
Fig. 31. Exterior view of a petaled hole in the fuselage skin of an unpressurized B-747 aircraft following the detonation of IED installed in luggage container. A longitudinal fracture originates from the hole [17].

An improvised explosive device (IED) usually used by terrorists, when detonated, creates a petaled hole in the fuselage skin (Fig. 31) [17]. Portion of the skin roll out and tear away from the center of the rupture, creating curls, as post-blast gases vent [17].

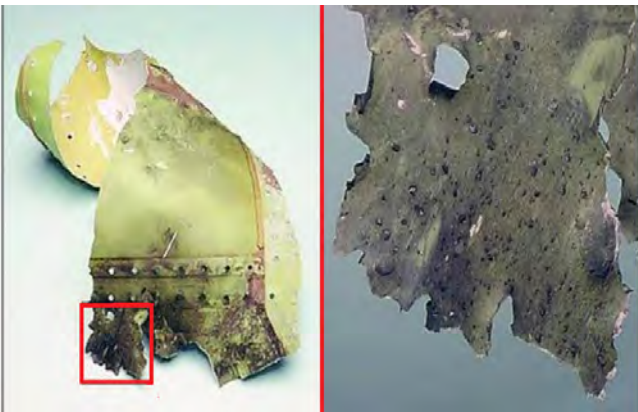
Fig. 32. Good example of explosive signature that shows pulled rivets, staining, microcraters, petaled hole, rolled edges (curl) and gas wash in the skin of an aircraft fuselage [17].

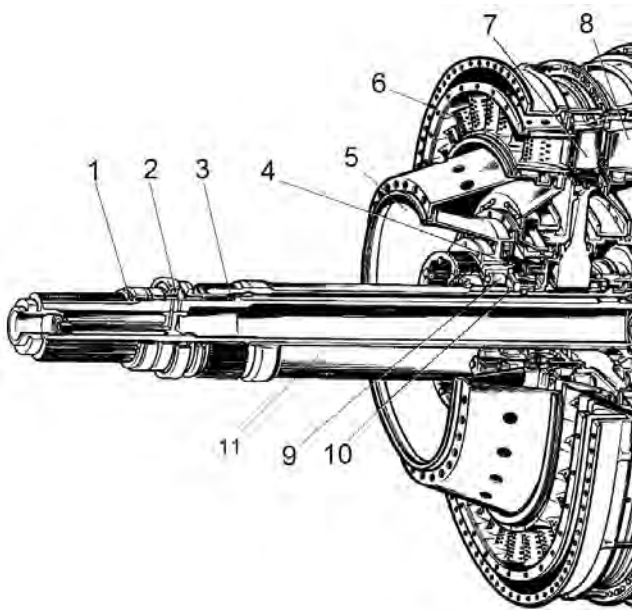
The weakness of construction of the D-30KU engine is the inter-shaft bearing joint between the shaft of the low-pressure turbine (LPT) and the shaft of the compressor fan (Fig. 47). This joint is difficult to access and to provide suitable sealing and intensive oil cooling. In this bearing the Russians removed every second roller (13 rollers out of 26) in the cage and drilled 3 holes in the inner race in order to create oil ducts [35].

Fig. 47 Portion of turbine of the DK-30KU turbofan engine: 1, 3, 10 - adjustment ring, 2 - inter-shaft bearing, 4 - support bracket of the high pressure turbine (HPT), 5 - eccentric adjustment ring, 6 - inlet guide vane (IGV) for the HPT, 7 - rotor of the 1st stage of the HPT, 8 - 2nd stage vanes, 9 - 3rd stage vanes, 11 - shaft of the rotor of the LPT.
